NASA-DoD Combined Environments Testing Results

Presented
by
Cynthia Garcia
Sr. Multi-Disciplined Engr I

October 28, 2010

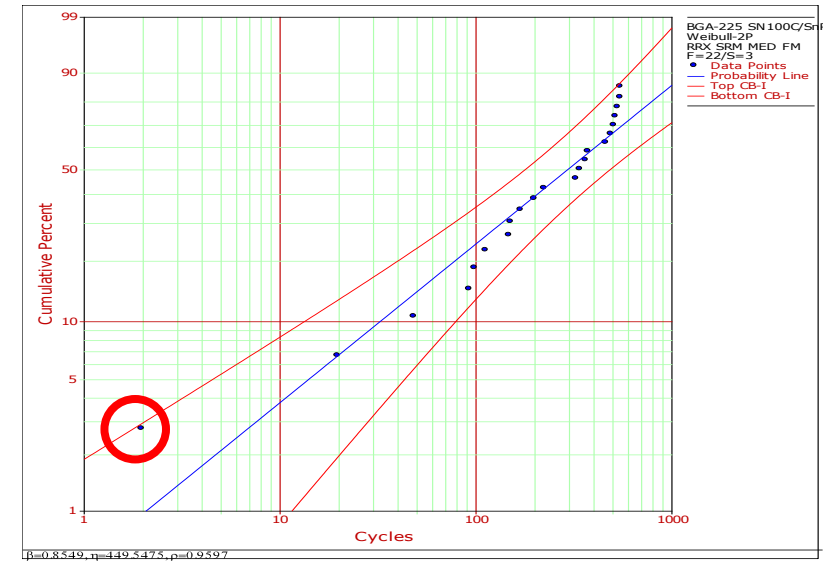
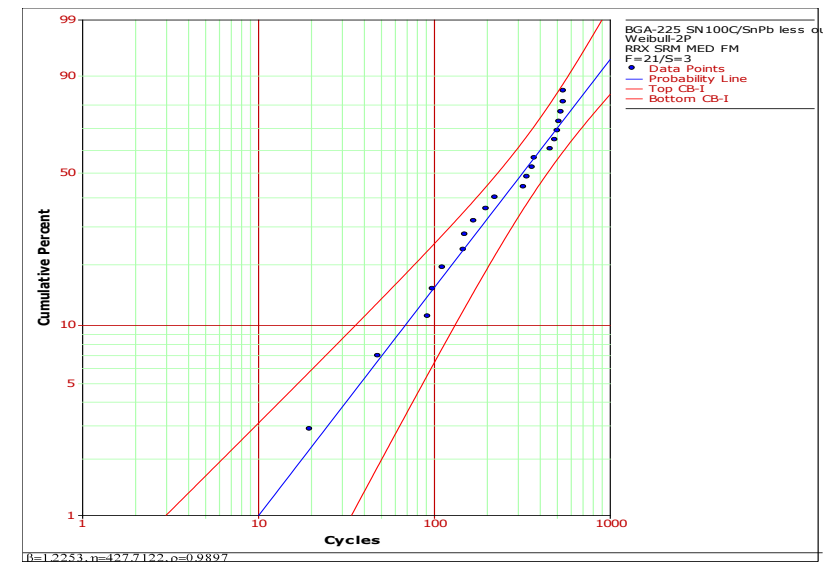
- Failures Less Than 10 Cycles
 - Treated as Outliers
- Two Weibull plots
 - One Showing Outliers
 - Second Plot Without
- Example
 - Mfg SN100C/SnPb BGA-225

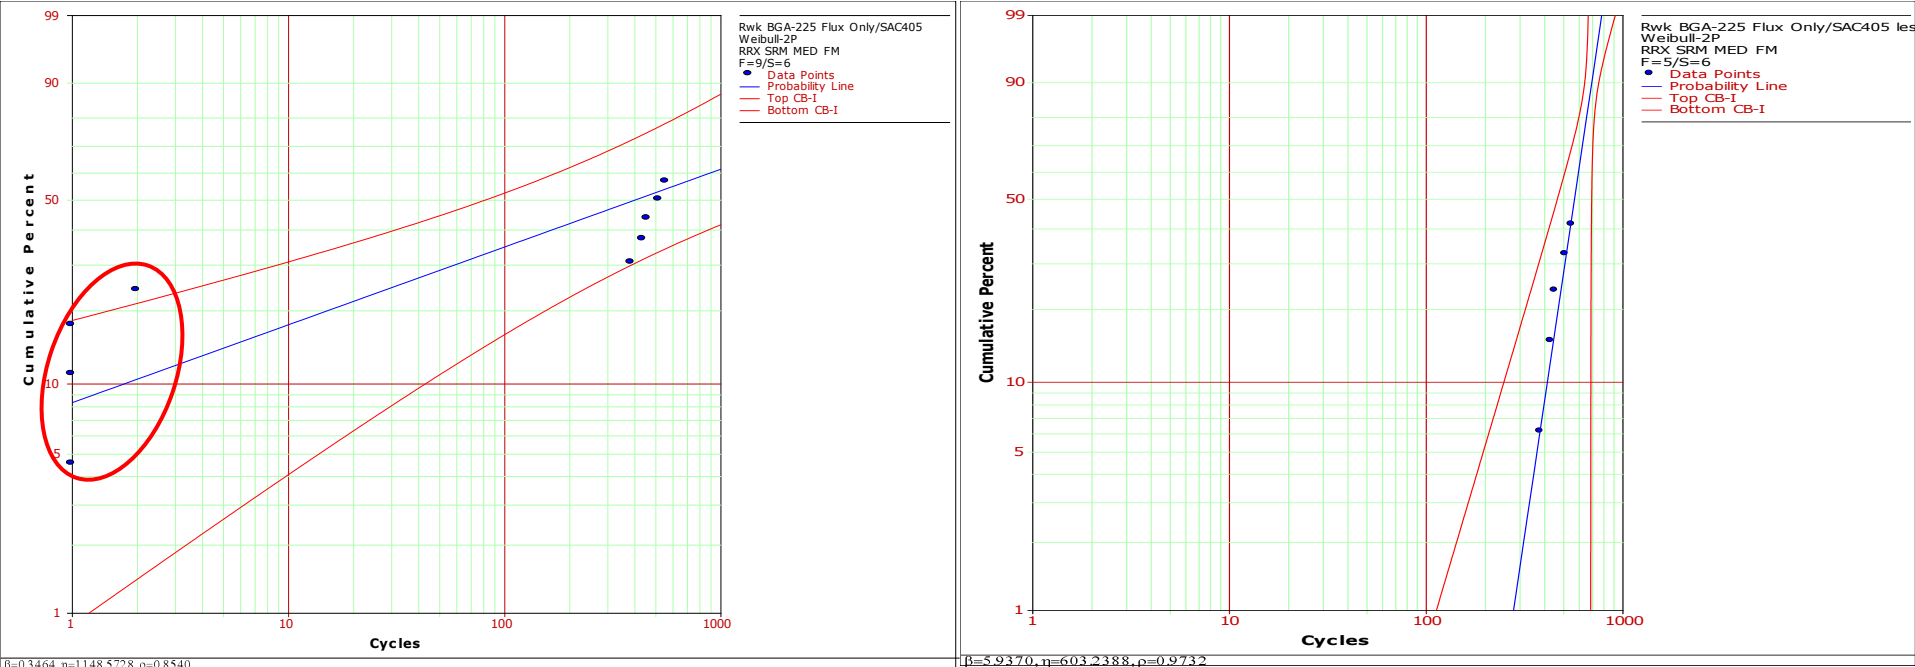
Rwk Flux Only/SAC405 BGA-225

- Shown Using Same Scale
- 2P Weibull Fit Affected by Outliers

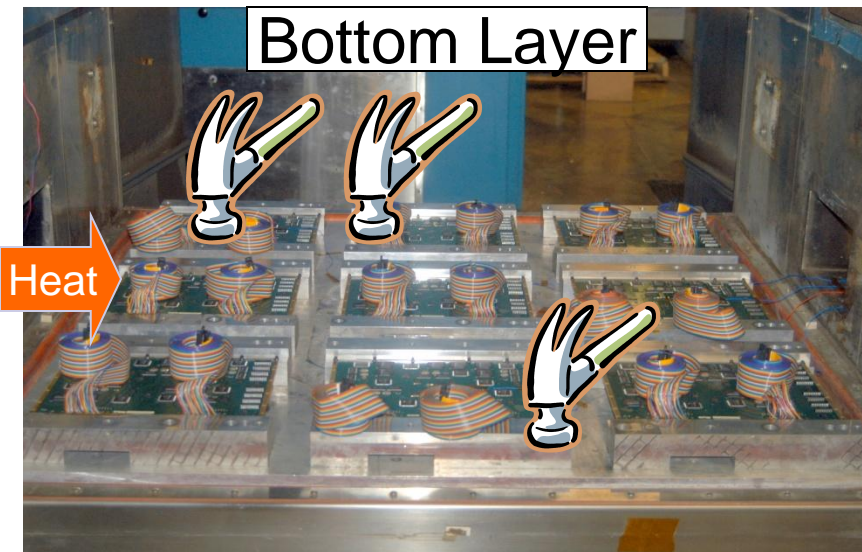
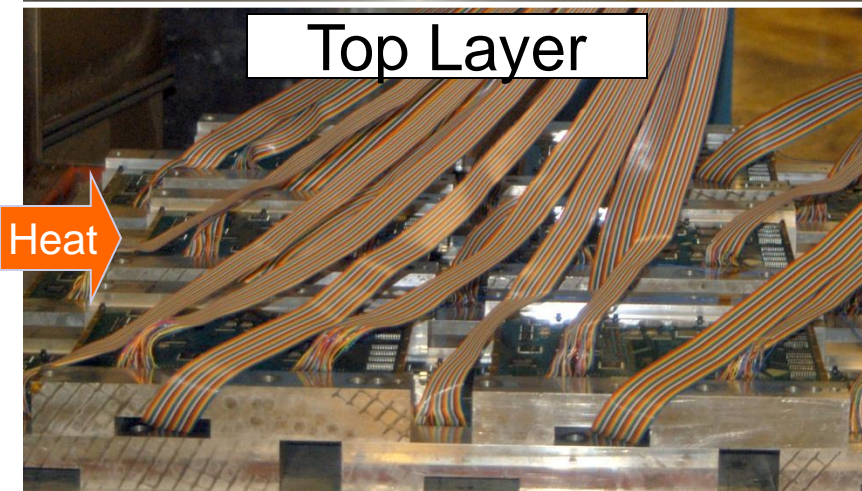
Location of TVs in Chamber

- TV SN 119 – Located Next to Heat Source

✗ - Low Fails
○ - High Fails

- Test Chamber
- Prior to Maintenance
 - Vibe Table Running Inefficient in Three Locations
 - Hammers Under TV SN 23, 69, 116 Running Inefficiently
 - Less Stress to Those Located Above Area

- Maintenance Performed
 - Three Hammers Replaced Between Run 1 and Run 2
 - Fine Tuning Performed Prior to Run 2
- As a Result
 - Hammers Distribute Vibe Efficiently in Run 2
 - Less Stress to Boards
 - Fewer Component Failures to Rework TVs

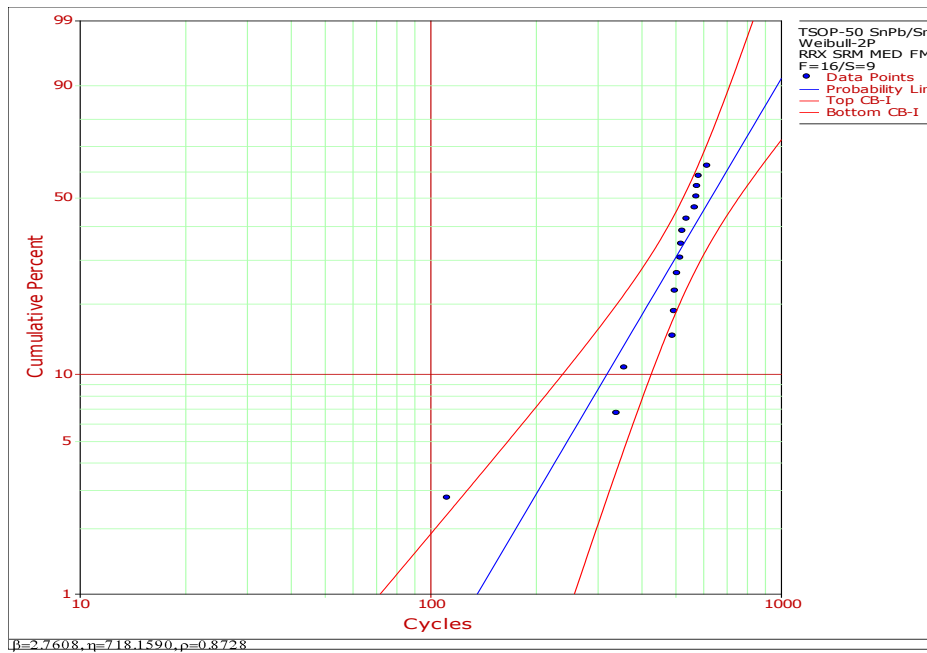
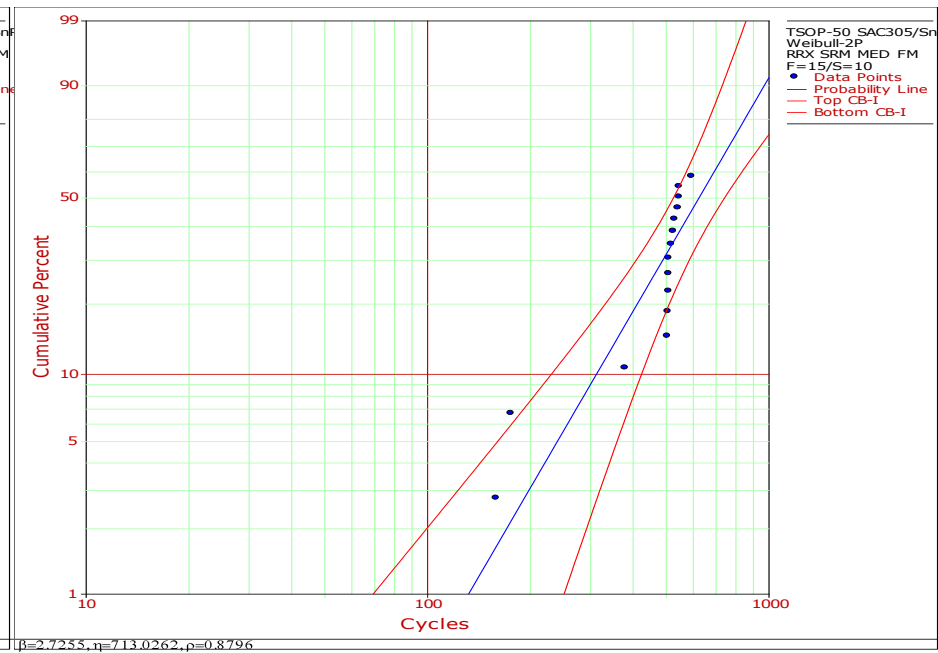
■ Mfg TSOP-50 SnPb/SnPb
 $\rho = 0.8728$
 Stair Step ~500 - 550 cycles

■ Mfg TSOP-50 SAC305/SnPb
 $\rho = 0.8796$
 Stair Step ~500 - 550 cycles

- Manufactured TVs at 500 Cycles
 - Vibration Levels were 55 g_{rms}
 - Vibe Table Strained to Maintain Specified level
- Attribute Stair Step to Noise
 - Mechanical Issues
 - Chamber Maximum Vibe is ~60 g_{rms}
 - Properties of Solder Changed
 - Indication of a New Failure Mode
- ★ Previous CET HALT and Thermal Cycle Testing Had Similar Phenomena

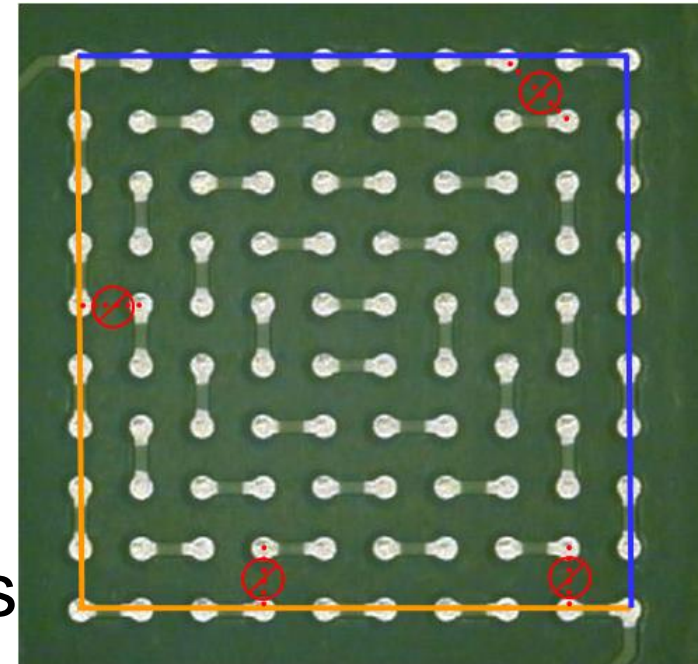
- Affected by
 - Incorrect Component Configuration in Drafting
 - Both Sides of Continuity Loop Must Break to Record an “Event”
- 2P Weibull Plots are not comparable to other Components
- Data Analysis Factor Must be Calculated for Reliability Comparison

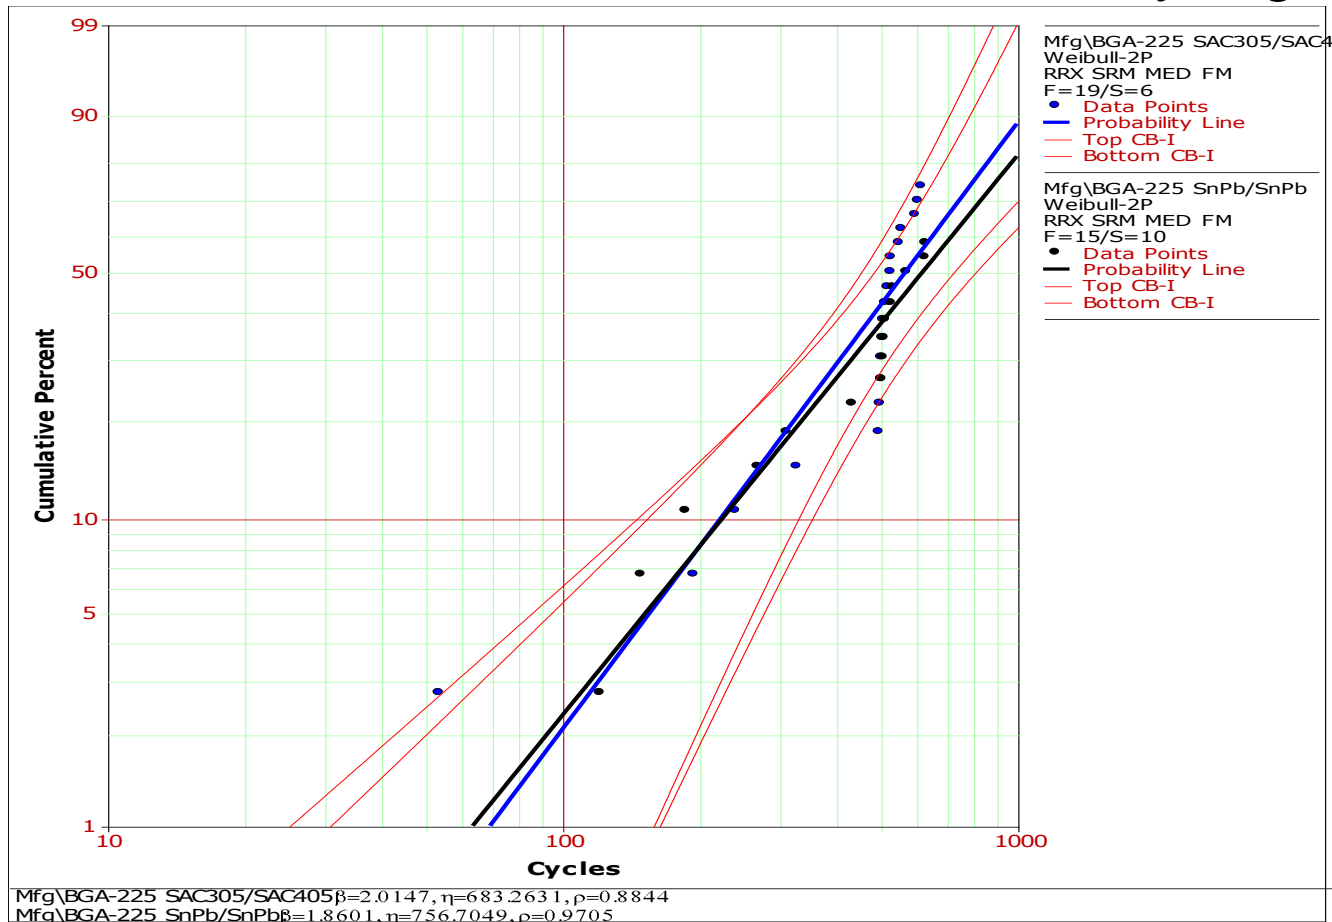
- BGA-225 SAC405/SAC305 vs SnPb/SnPb
 - Probability of Tin-Lead Lasting Longer Than SAC405/SAC305 is 54% - Not Statistically Significant

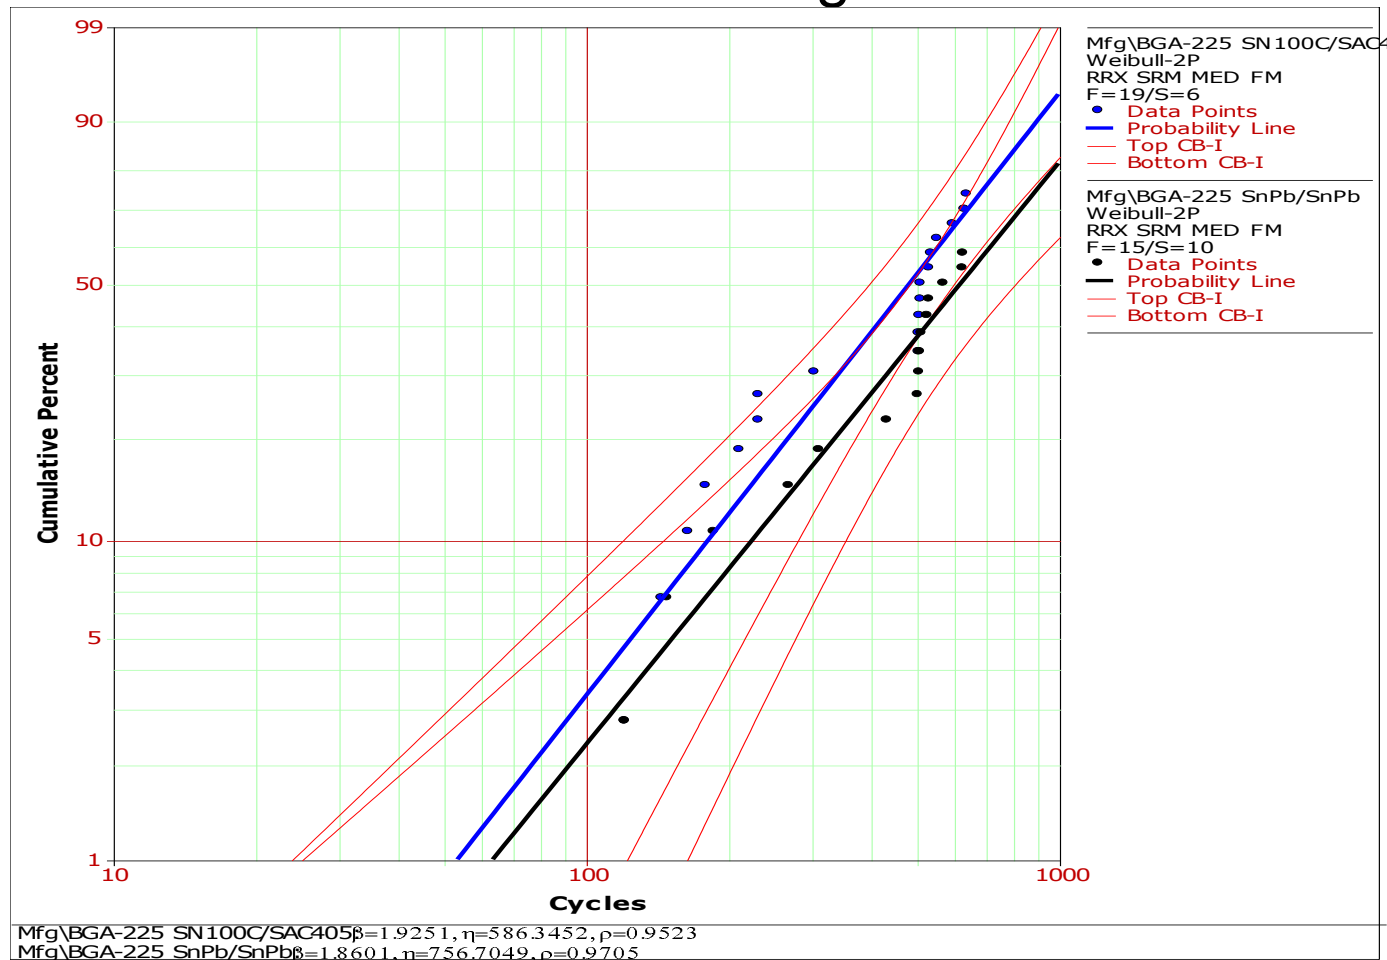
■ BGA-225 SN100C/SAC405 vs SnPb/SnPb

- Probability of Tin-Lead Lasting Longer Than SN100C/SAC405 is 62% - Significant

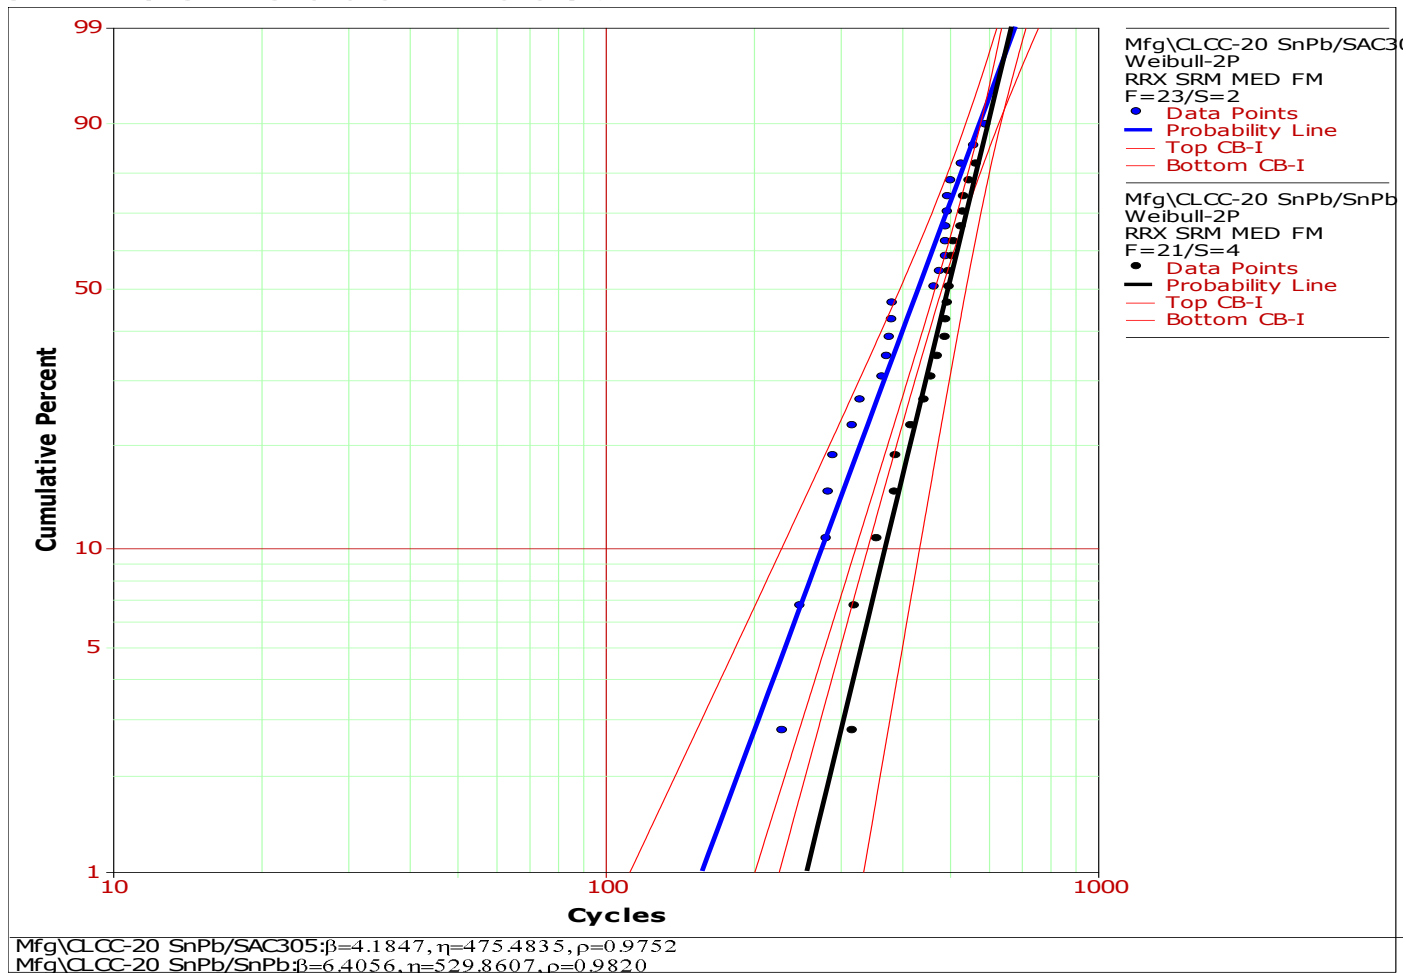
■ CLCC-20 SnPb/SAC305 vs. SnPb/SnPb

- Probability of Tin-Lead Lasting Longer Than SnPb/SAC305 is 66%

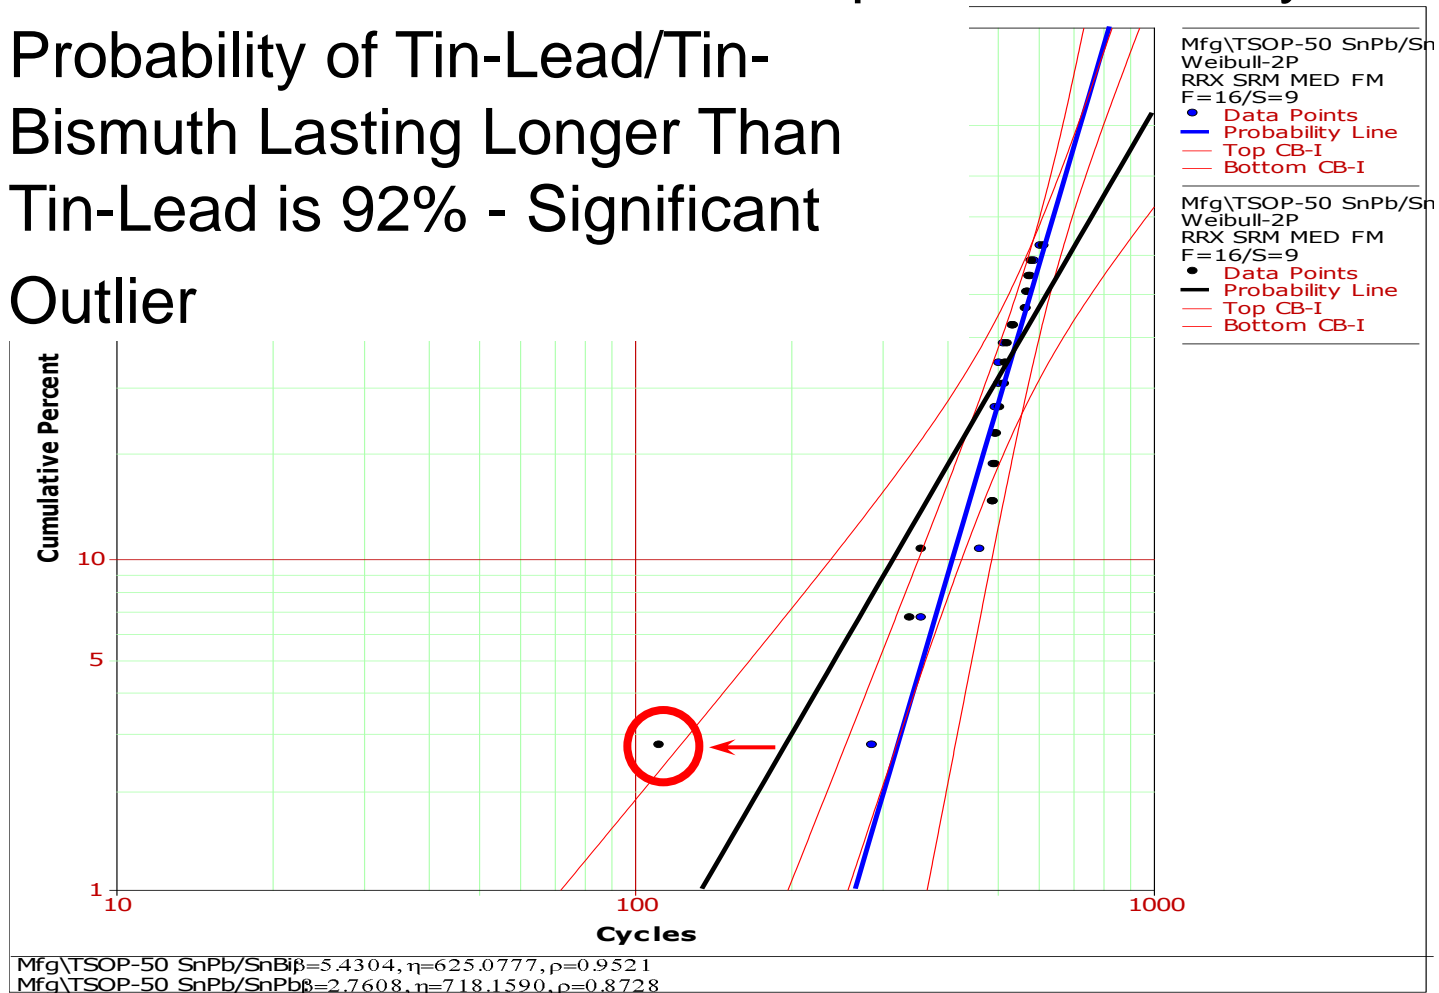
■ TSOP-50 SnPb/SnBi vs. SnPb/SnPb

- Data Point has Influenced Slope of Probability Line
- Probability of Tin-Lead/Tin-Bismuth Lasting Longer Than Tin-Lead is 92% - Significant
- Outlier

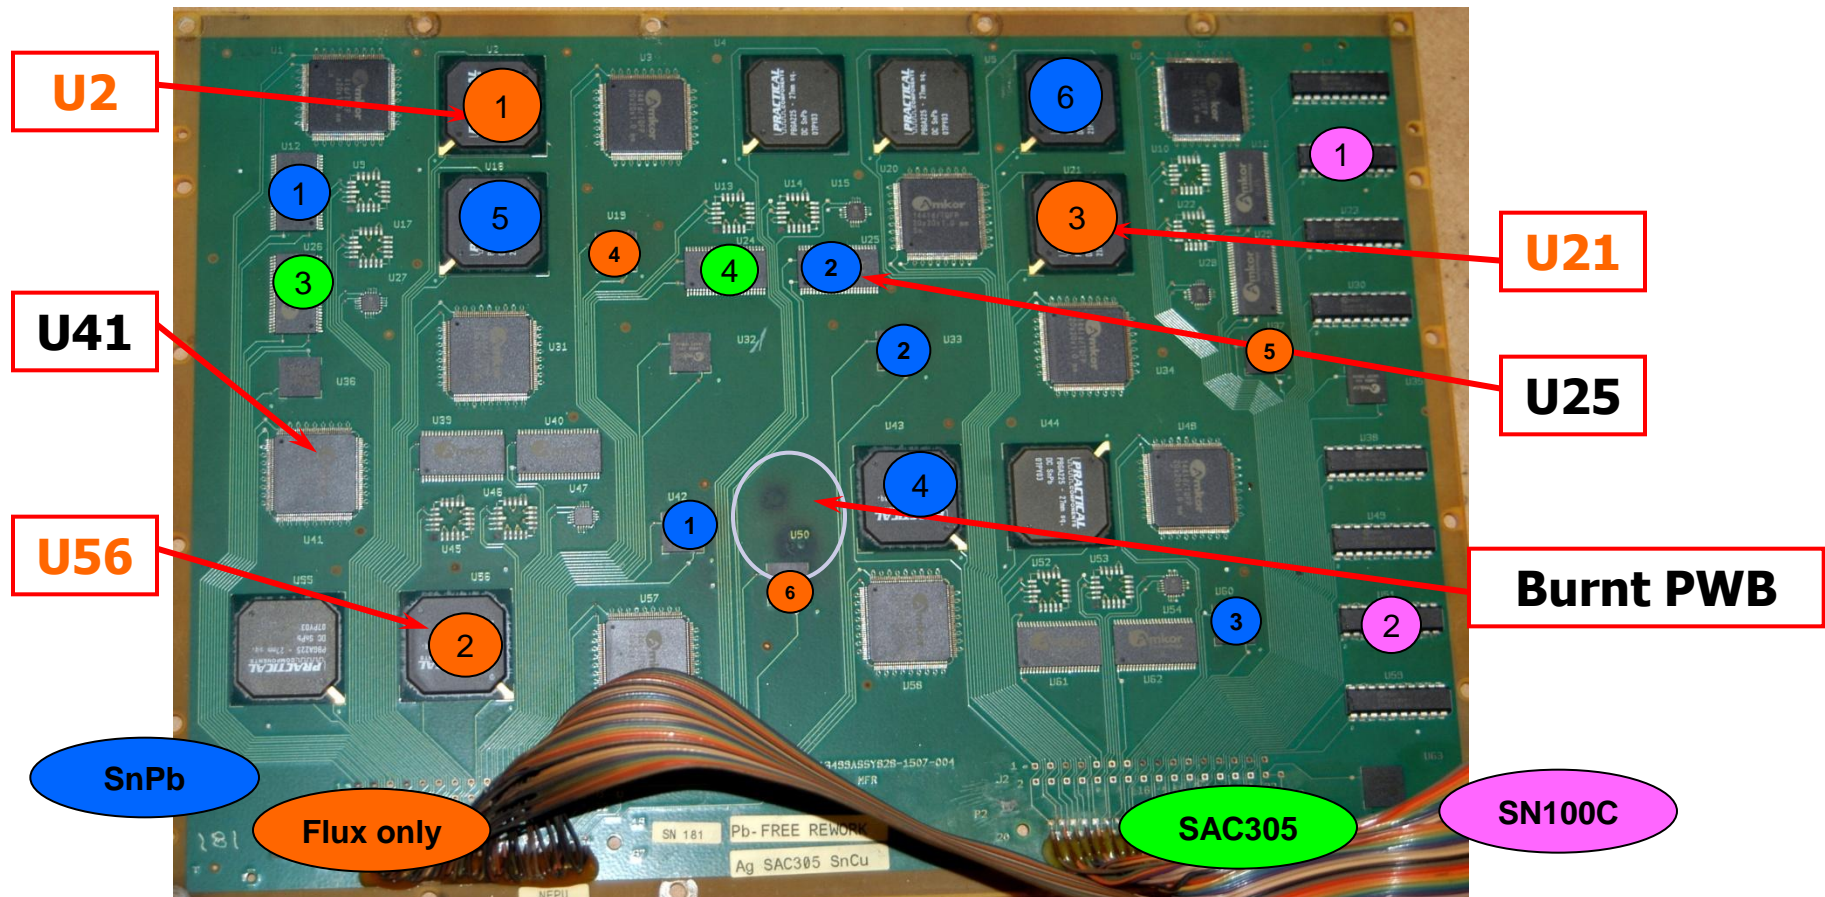
Result of Rwk TV SN 181 (Batch A)

- Multiple Early Life Failures, Qty 3 BGA-225 Rwk with Flux Only/SAC405
 - U41 Not Reworked – Rework Induced Failure?

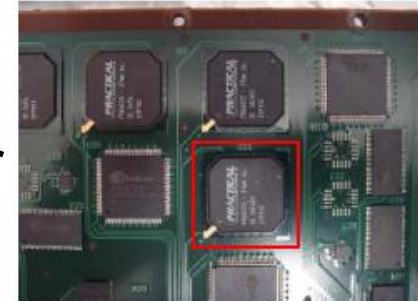
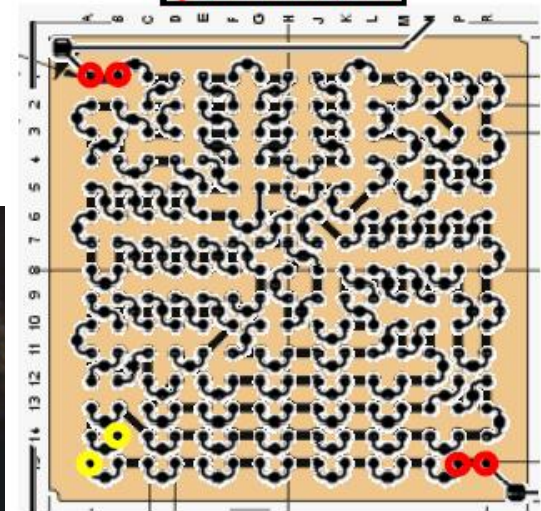
Test Vehicle 180

Pb-Free REWORK
Ag-SAC305-SnCu

⑤ U21 (BGA225)
